Independent Environmental Audit Report 5 (IA5) Deicorp Construction Pty Ltd

Tallawong Station Precinct South (SSD 10425) Rouse Hill NSW

Audit Date: 24 October 2023

Morasey Ref: MEDEI: 2023100-05

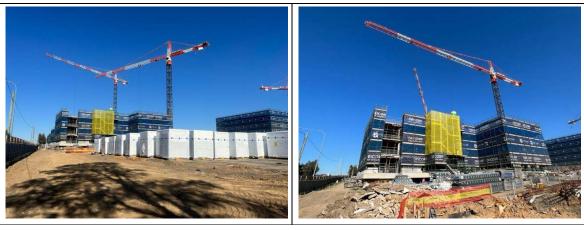
Photos 5 & 6: Site 2 – Tower construction progress (Stage 2D)

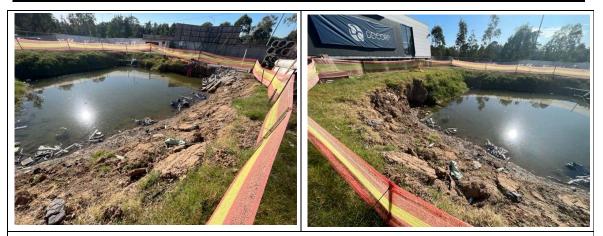
CoA# / Plan Reference	Summary of Observation	Recommended Action Due Date Status
D22	Observation 1: The western edge of the sediment basin had been excavated to increase capacity, exposing underlying soil. Exposed earth in the SE corner of Site 2 is a dust risk.	Recommended Action: Stabilise western edge of the sediment basin and consider further stabilisation of exposed earth areas along the southern boundary of the site. Due Date: ASAP – To be verified during IA6, April 2024 Status: OPEN

Photos 7 & 8: Sediment basin, SE corner of Site 2. Rubbish recommended for removal, as well stabilisation and seeding of the disturbed batter.

Recommendation: Deicorp should consider further stabilisation measures to reduce dust	
	risk in this location.

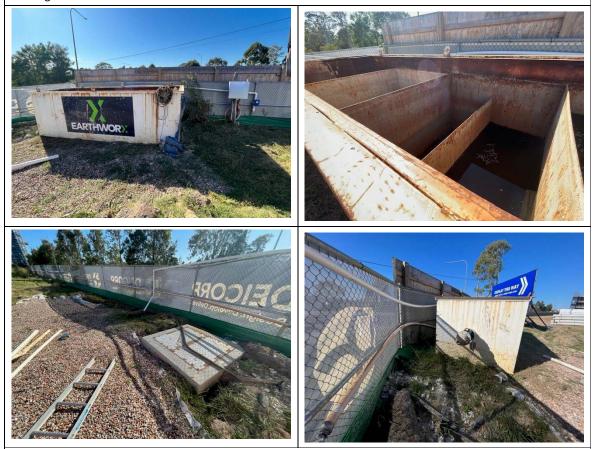
Photos 9-12: Sediment basin, SE corner of Site 2. Rubbish recommended for removal, as well stabilisation and seeding of the disturbed batter. Discharge controls in place.

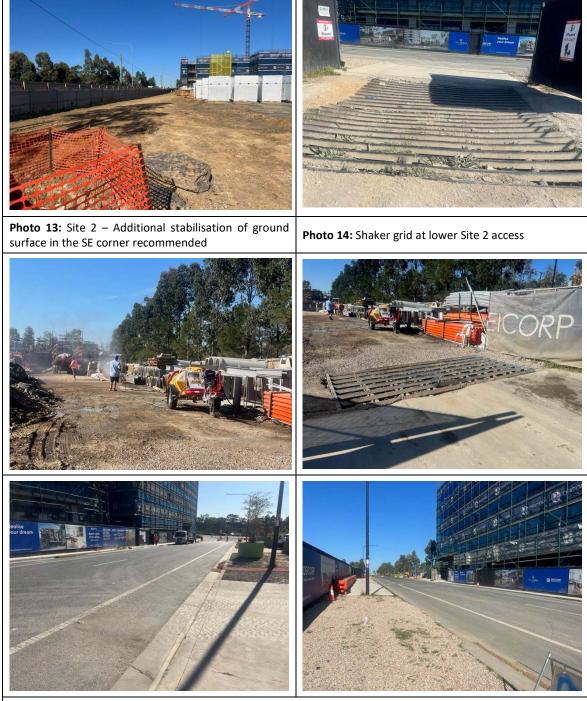
Photos 15-18: Shaker grid at upper Site 2 heavy vehicle access maintained in good condition. Dust suppression using gurney. Minimal tracking along Conferta Avenue.

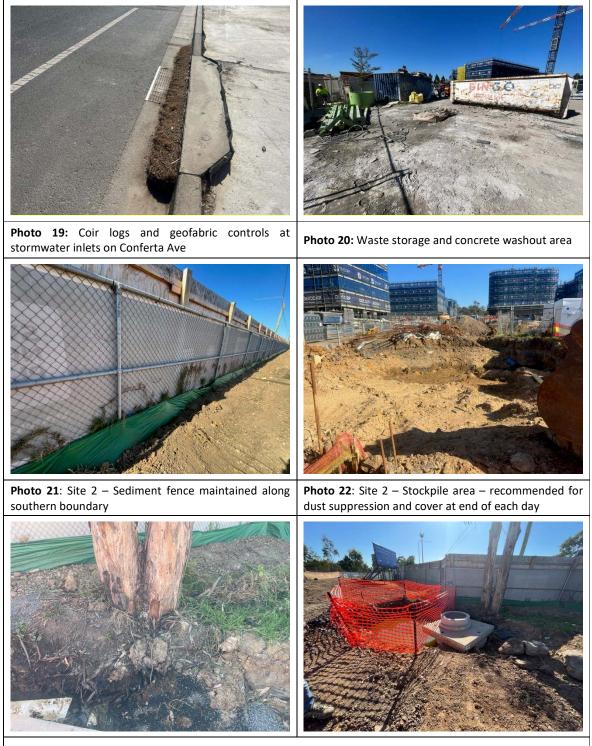
Photos 23 & 24: Tree damage from sewer installation in SE corner of Site 2. Deicorp advised tree does not require retention and would be removed prior to Stage 3 works commencing
