06 June 2025

**RE: Independent Environmental Audit Report 8 (IA8)
Tallawong Station Precinct South (SSD 10425)**

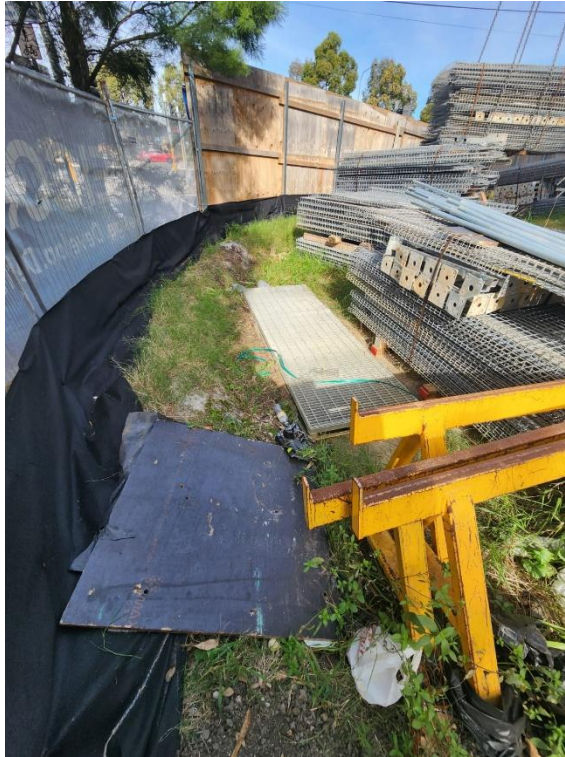
D14 Observation
2

CoA	Summary of Observation – IA8
D14	<p>Observation 1: Weeds were overgrown throughout landscaped areas outside the site boundary along Cudgegong and Schofields Roads</p> <p>Recommendation: Deicorp to confirm responsibility for weed management and follow-up on the implementation of weed management measures.</p>
	<p>Observation 2: Fencing panels and other materials were stored on top of and around the main live stormwater inlet inside the site on the corner of Cudgegong and Schofields Roads.</p> <p>Recommendation: Clear an area around the stormwater inlet and apply erosion and sediment controls to reduce the risk of sediment and pollution entry.</p>
	<p>Observation 3: Jerry cans of fuel were stored on an unsealed ground surface with no bunding in place.</p> <p>Recommendation: Provide GHS compliant storage for jerry cans of fuel and other hazardous chemicals, including bunding.</p>

Deicorp have cleared around the stormwater inlet area and applied erosion and sediment controls similar to the nature of the site.
