## **Independent Environmental Audit Report 3 (IA3)**

**Deicorp Construction Pty Ltd**

**Tallawong Station Precinct South (SSD 10425)**

**Audit Date: 10 October 2022**

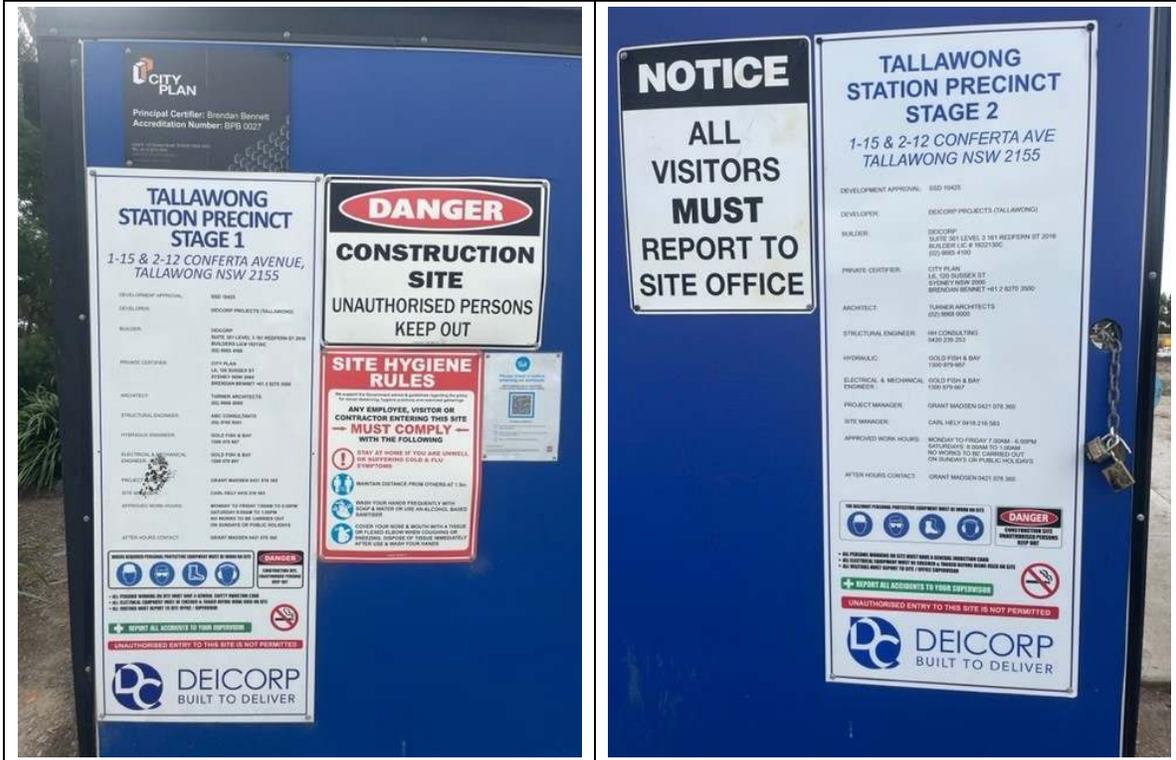
Photo 1: Compliant site signage at Site 1 entry

Photo 2: Compliant site signage at Site 2 entry

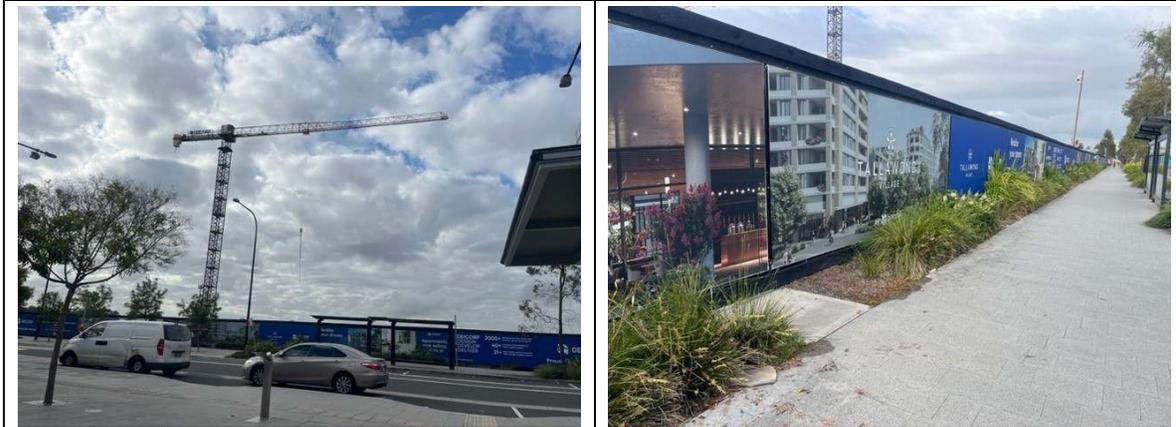
Photo 3: Site 1 as viewed from Tallawong Metro Station

Photo 4: Hoarding on the northern site boundary along Themeda Ave

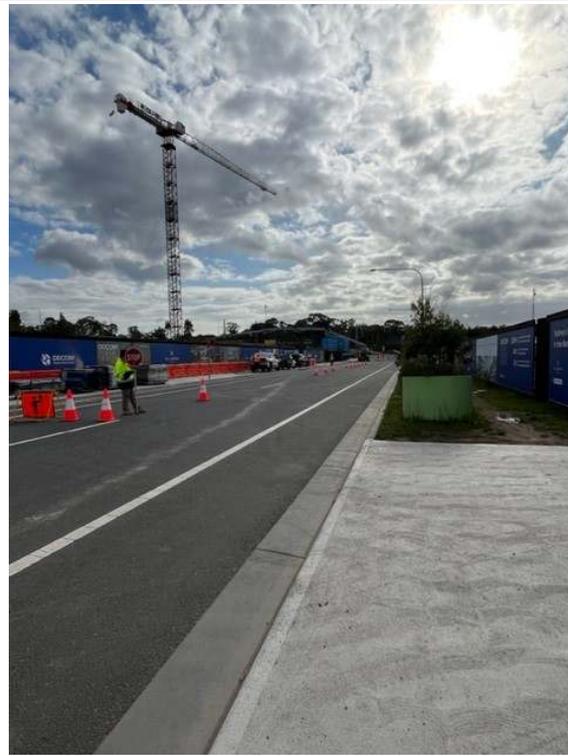
**Photos 5:** Clean hardstand western access to Site 2 and traffic control in place for lane closure on Conferta Ave

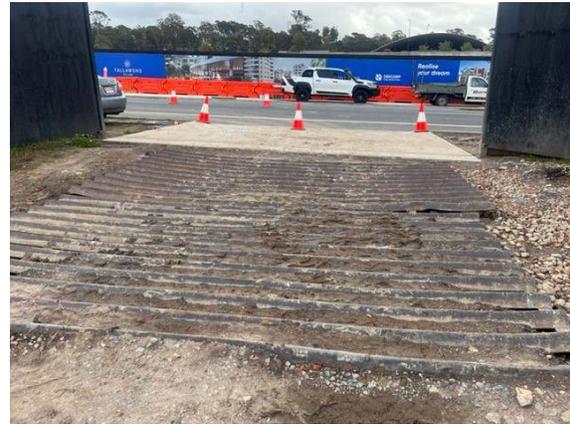
**Photos 6:** Clean eastern access to Site 2 with rumble grid in place

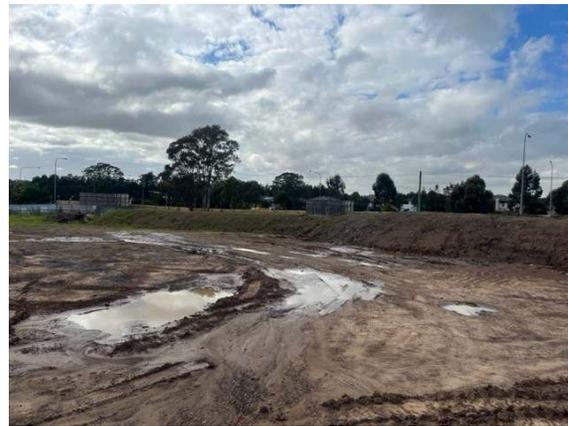
**Photo 7:** Stockpiling of topsoil, Site 2

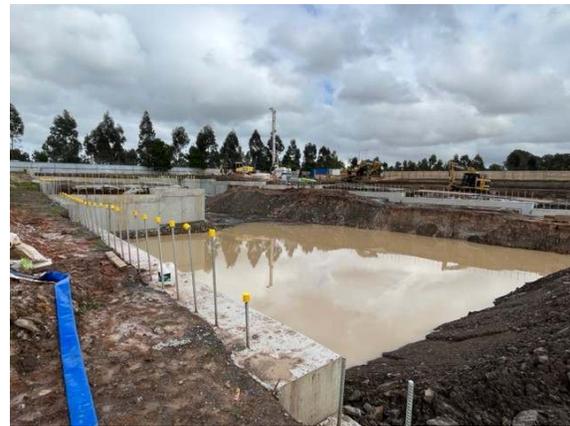
**Photo 8:** Water in basement excavation, Site 2. Capping beams installed.

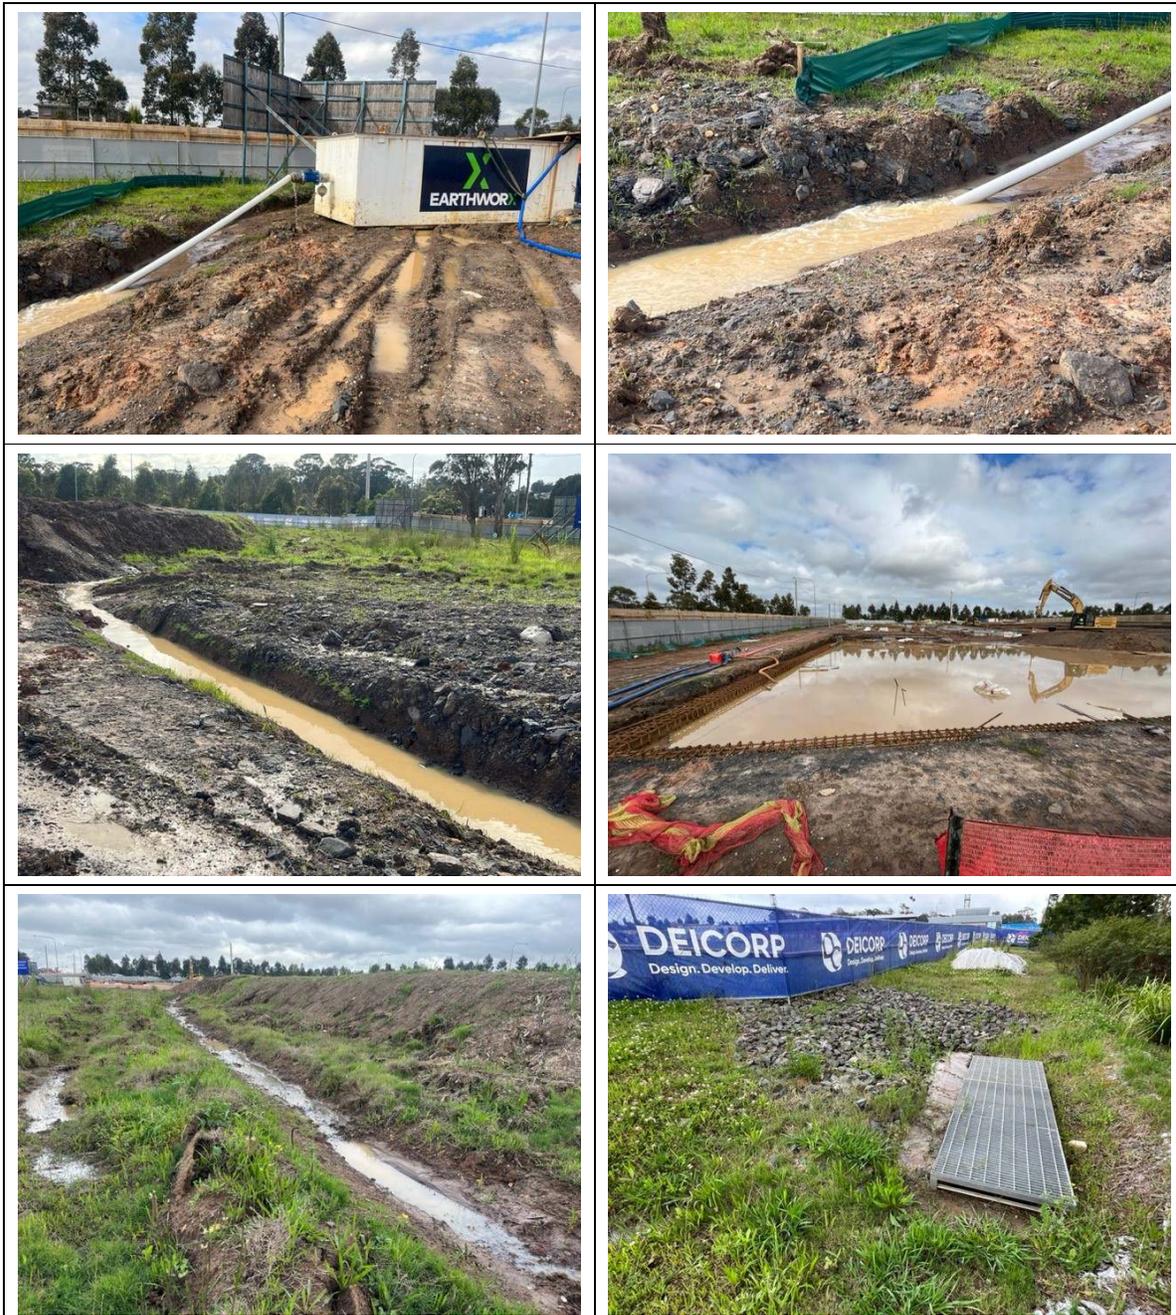
D25	At the time of IA3, there was no evidence of water quality sampling being conducted during the discharge of water from Site 2.	<b>Recommended Action:</b> Implement the Dewatering Management Plan for Site 2 to ensure compliance with Condition D25. <b>Due Date:</b> 15/11/2022 <b>Status:</b> OPEN

Section 5.3 Groundwater Quality Monitoring	<p>Dewatering had commenced on Site 2 at the time of audit, though visual monitoring requirements as documented in the DMP had not yet been implemented.</p>	<p><b>Recommended Action:</b> Conduct and record visual inspections (daily where possible) for Site 2 in accordance with Section 5.3 Groundwater Quality Monitoring of the DMP.</p> <p><b>Due Date:</b> 15/11/2022</p> <p><b>Status:</b> OPEN</p>

**Photos 9-14:** Dewatering process underway on Site 2 from basement excavations to stormwater. Implementation of the Soil and Water Management Plan required to ensure sediment does not leave site

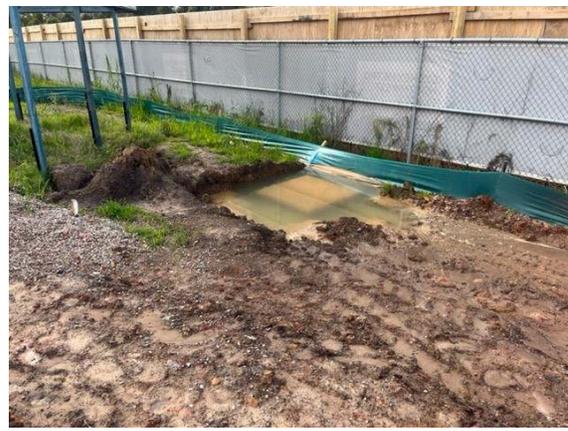
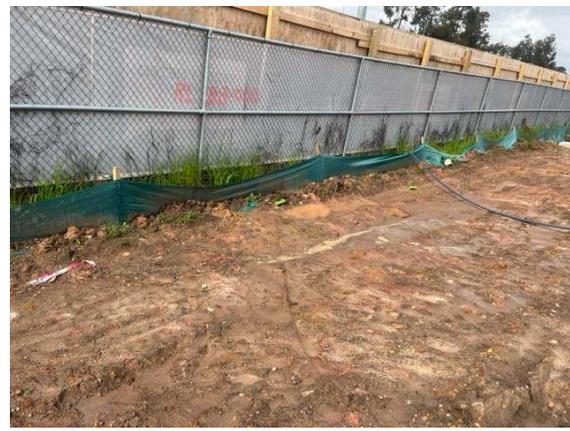
CoA#	Summary of Non-Compliance	Recommended Action Due Date Status
<b>CEMP, Tallawong Station Precinct South – Site 2, 30 May 2022</b>		
Section 10 Soil and Water Management	<p>There were no ERSED controls in place along the swale, which was created with bare earth, potentially increasing sediment load prior to discharge to the stormwater system.</p> <p>Drainage rock had been applied by a previous contractor around the stormwater inlet outside the site on the corner of Schofields and Cudegong Road.</p>	<p><b>Recommended Action:</b> Review and implement the Soil and Water Management Plan to reduce the risk of sediment entering the stormwater system.</p> <p><b>Due Date:</b> 15/11/2022</p> <p><b>Status:</b> OPEN</p>
<b>Dewatering Management Plan (DMP) – Site 1 &amp; 2</b>		
Section 4.4 Dewatering Method	<p>The preparation of a Site Dewatering Strategy was in progress at the time of the audit. Deicorp were in the process of engaging a specialist to provide advice on water treatment options / equipment required, based on the first round of water quality monitoring results for Site 2, which were pending at the time of this IA3.</p> <p>As excavation had already commenced at the time of this IA3, the project was Non-Compliant with Section 4.4 of the DMP at the time of the audit for Site 2.</p>	<p><b>Recommended Action:</b> Finalise and agree on the Dewatering Strategy for Site 2 in accordance with Section 4.4 Dewatering Method of the DMP.</p> <p><b>Due Date:</b> 15/11/2022</p> <p><b>Status:</b> OPEN</p>

**Photos 15 & 16:** Sediment fence in place but to be maintained along the southern site boundary, Site 2

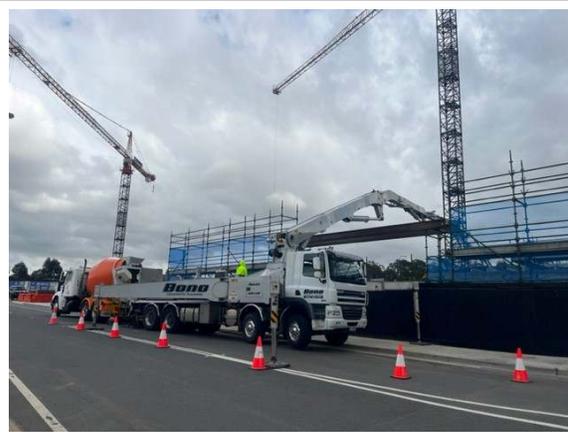
**Photo 17:** Concrete pour underway into Site 1 from Conferta Ave work zone

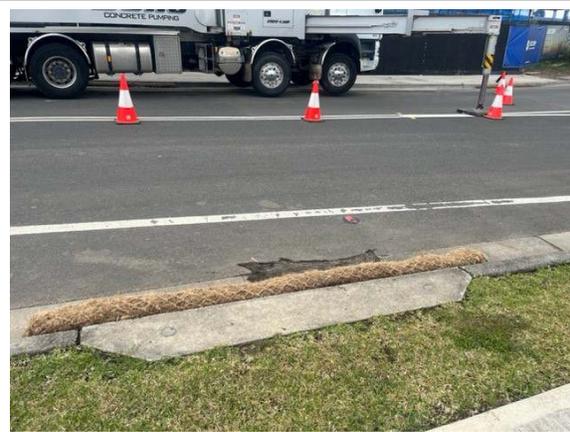
**Photo 18:** ERSED controls in place along Conferta Ave stormwater inlets

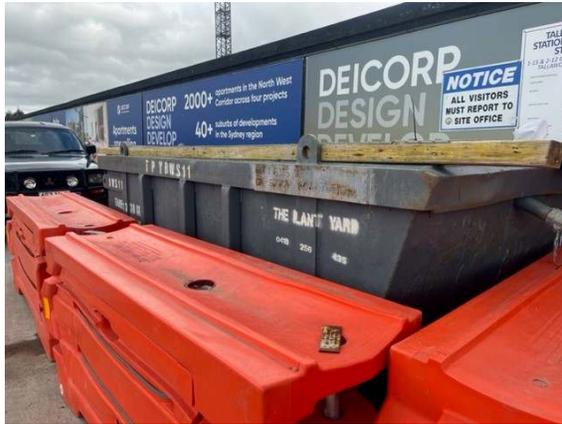
Photo 19: Water holding/settling tank, Conferta Ave works zone, Site 1

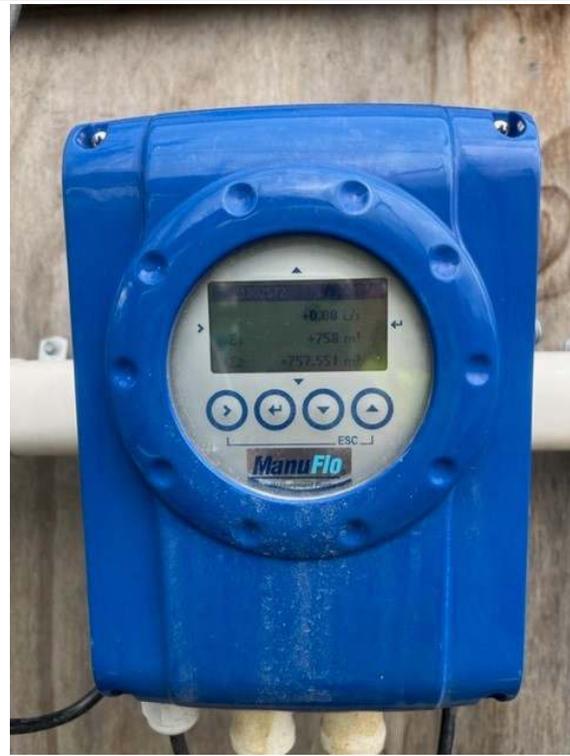
Photo 20: Flow meter – Site 1

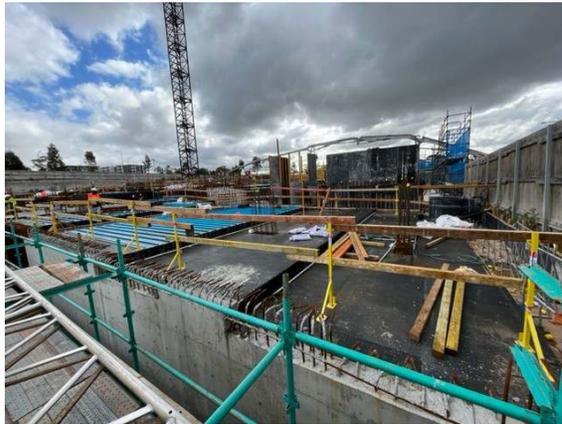
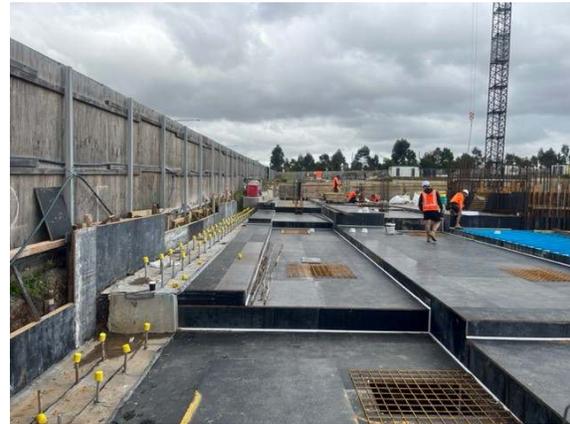
Photos 21 & 22: FRP works and progress, Site 1
