Independent Environmental Audit Report 7 (IA7)

Deicorp Construction Pty Ltd

Tallawong Station Precinct South (SSD 10425)

Audit Date: 17 October 2024

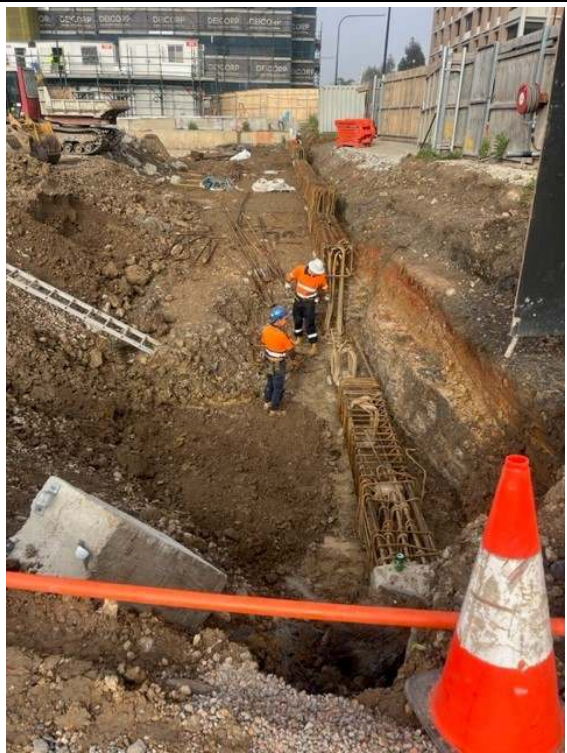
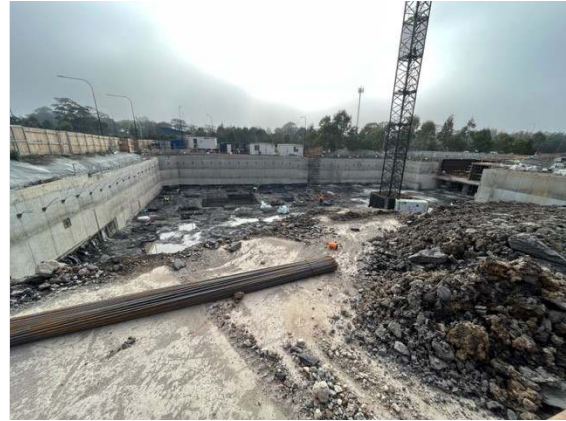
Photos 1 & 2: Construction of capping beams and basement excavation on southern side of Conferta Avenue

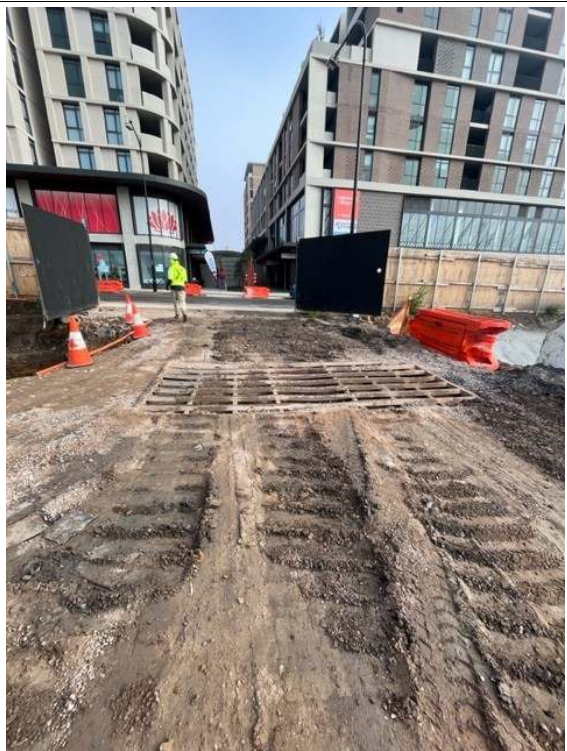
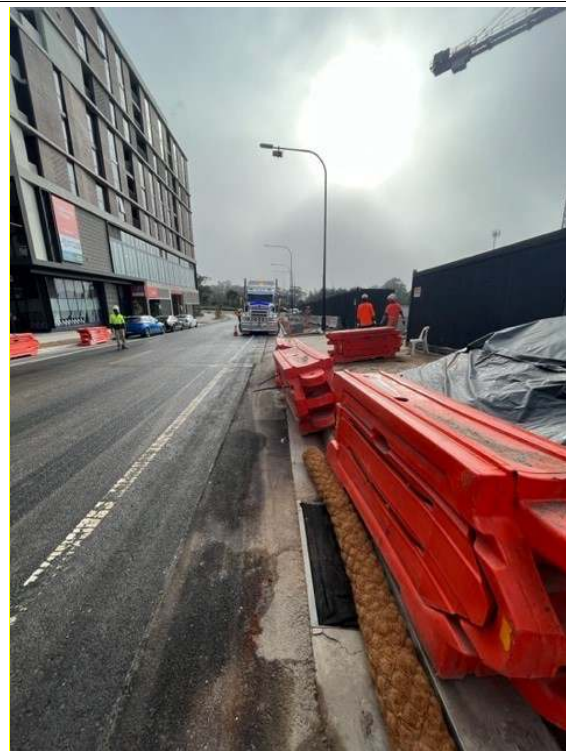
Photos 3 & 4: Stabilised site access and controls around stormwater drains on Conferta Avenue. Street sweeper observed to be in use.

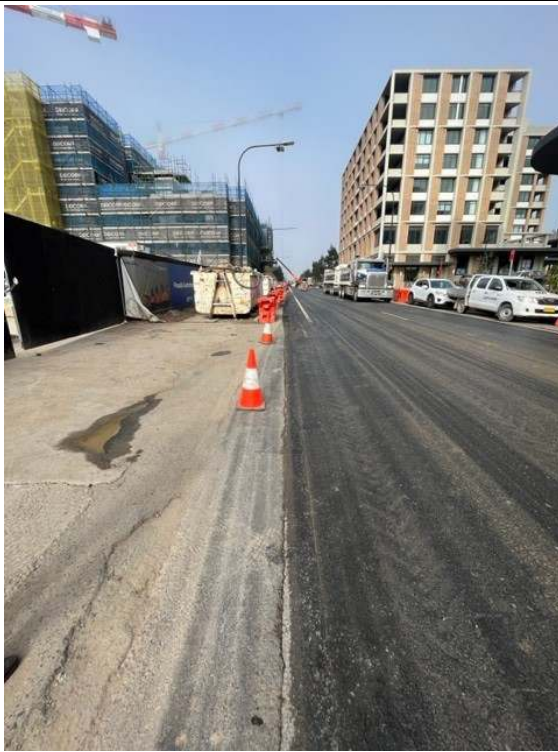
Photo 5: Work Zone and traffic control in place on Conferta Ave

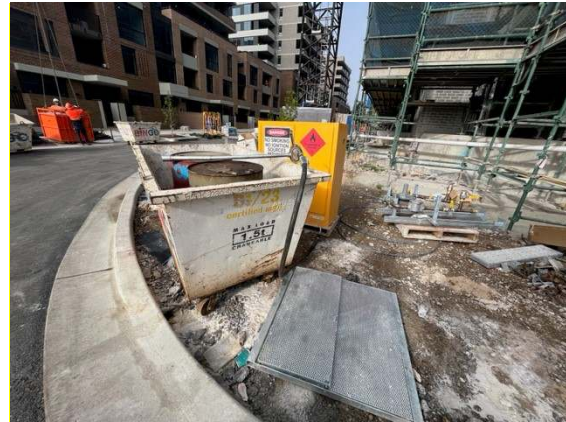
Photo 6: Diesel storage in drums in skip bin– to be moved to more suitable location

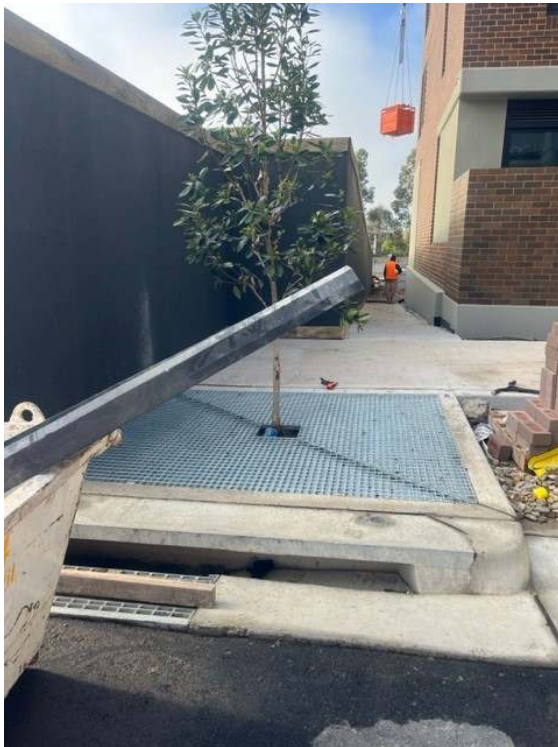
Photo 7: Tree planting and maintenance noted

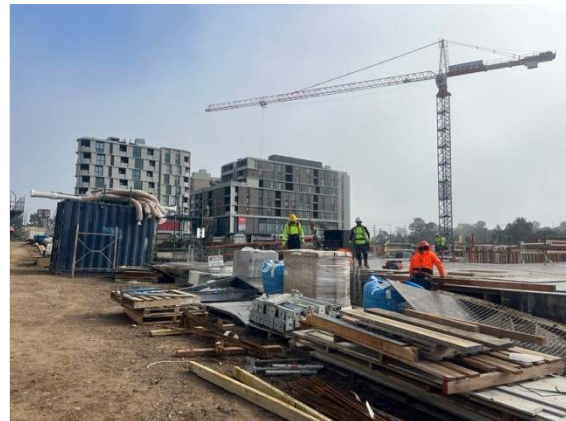
Photo 8: Tower construction ongoing on Site 2

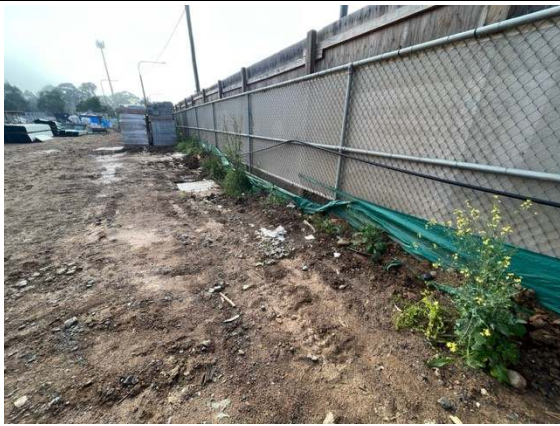
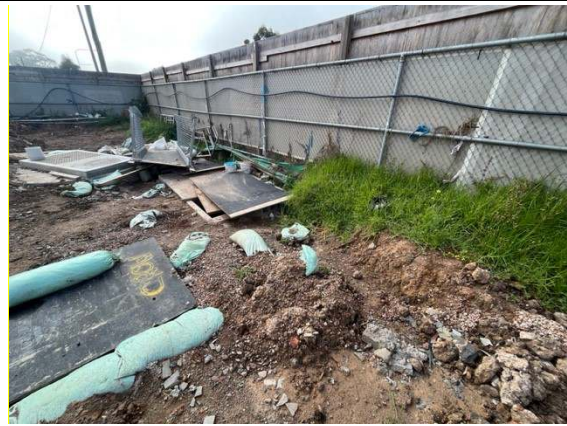
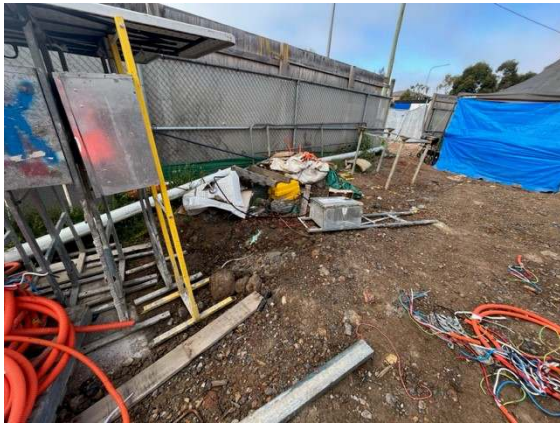
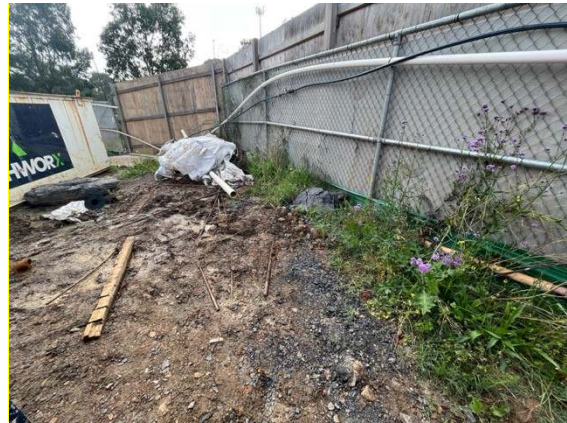
D23	Observation 3: A sediment fence was in place along the inside of the southern boundary fence but had come away in several locations and had not been well maintained since the last audit. Various miscellaneous materials were stored around the site boundary.	Recommended Action: Repair sediment fencing and move materials away from the site boundary / improve housekeeping. Due Date: ASAP Status: OPEN
D23	Observation 4: One stormwater inlet on Conferta Avenue was not adequately protected and risk of sediment entry was identified.	Recommended Action: Provide and maintain adequate controls around stormwater inlets to reduce the risk of sediment entry. Due Date: ASAP Status: OPEN

Photos 9-12: Sediment fencing was in poor condition along the southern boundary of the site. Housekeeping improvements were also required along the boundary.

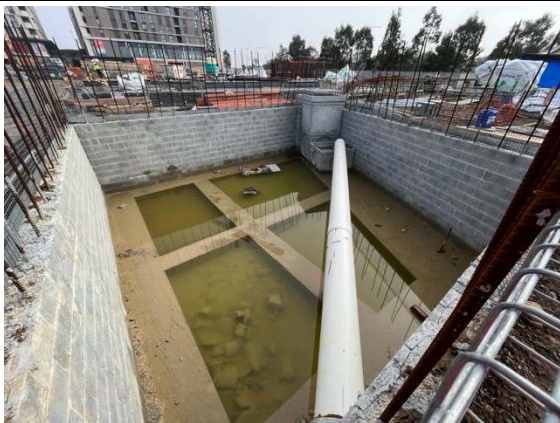
Photo 13: The OSD tank was being used for the temporary storage of water prior to discharge offsite

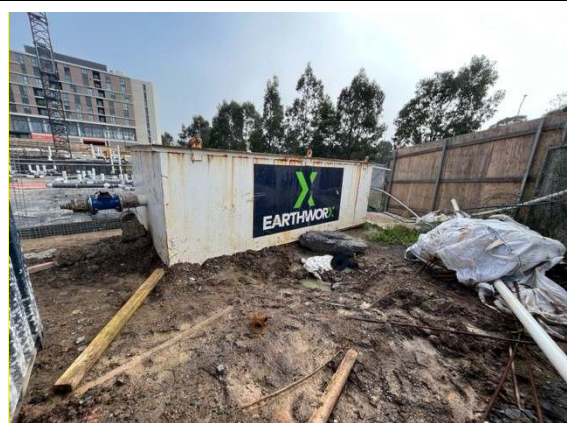
Photo 14: A sediment tank remained in place where water testing is undertaken prior to discharge

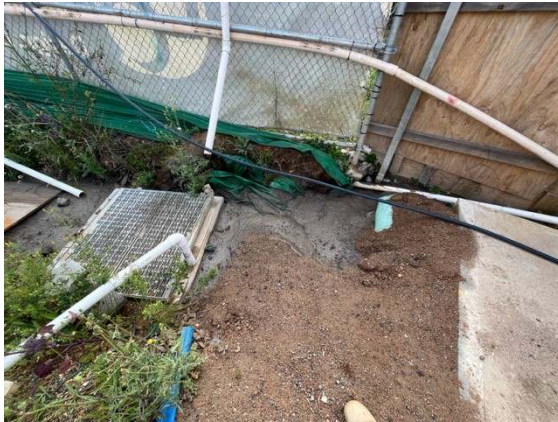
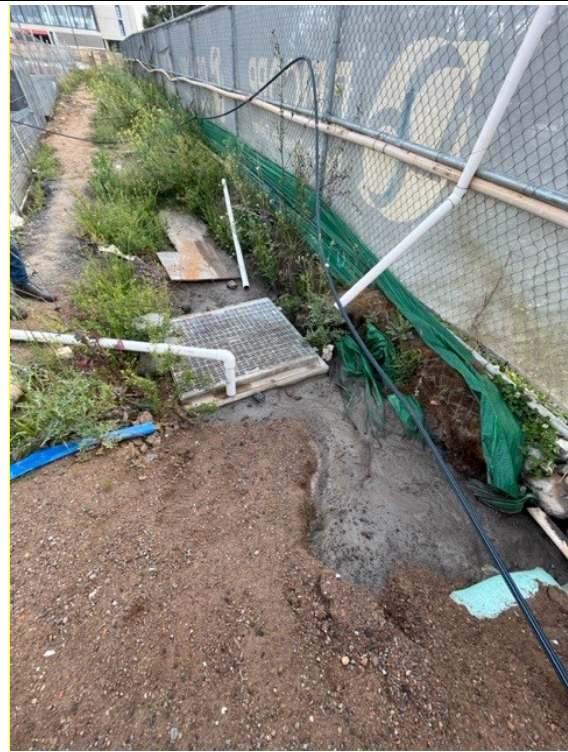
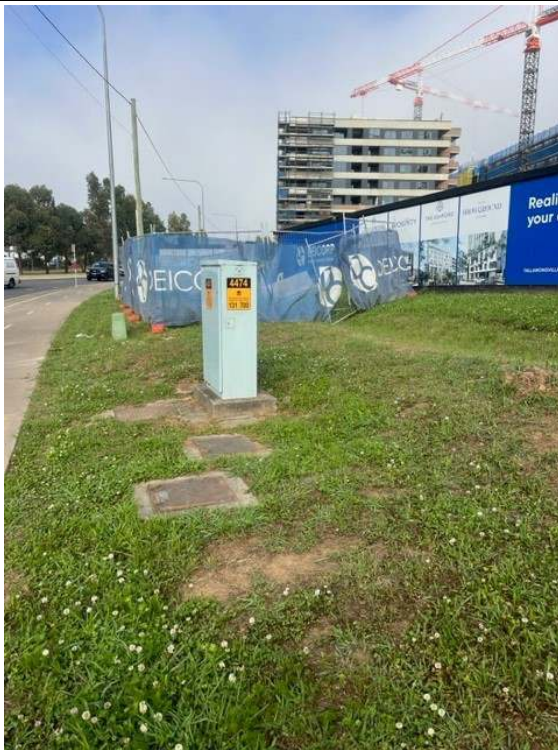
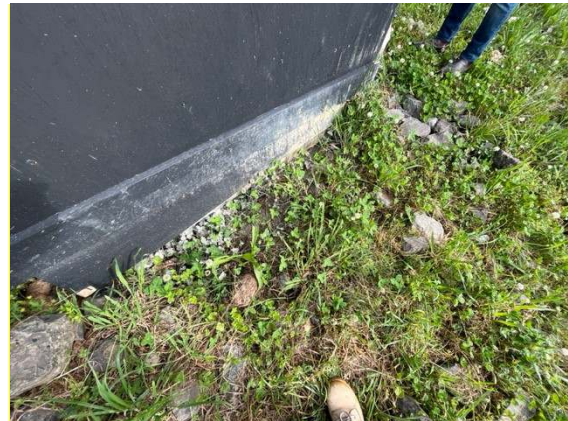
Two environmental incidents were identified during the audit site inspection, which had not been reported in a formal Incident Report. In one instance, concrete slurry had been deposited in the swale leading to the stormwater discharge point on the corner of Schofields and Cudgegong Road. In the 2nd instance there was evidence of a concrete spill that had been cleaned up on either side of a stormwater drain on Conferta Avenue. Recommendations have been made in relation to implementation of the environmental reporting system, including the raising and awareness of environmental incidents.

Photos 15-18: Concrete slurry was observed in the clean water swale in the southeast corner of the site. The slurry could not be seen migrating outside the site boundary or to stormwater. An investigation was recommended to be undertaken by the auditor.

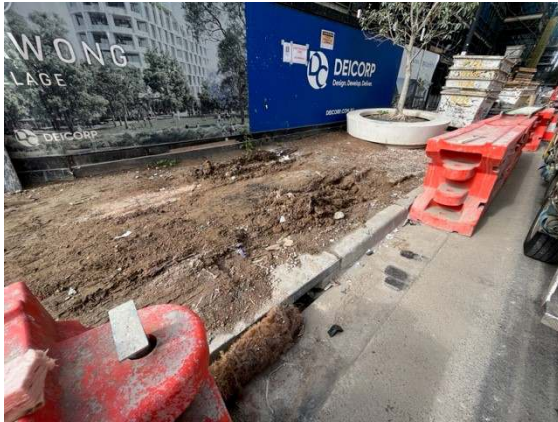
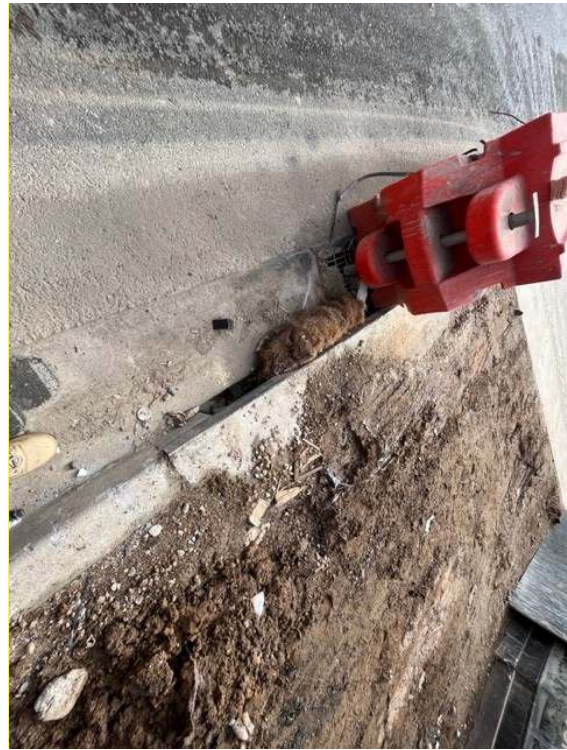
Photos 19&20: Disturbed soil was spilling into the gutter on Conferta Road. The controls around the stormwater drain in this location were inadequate, posing a risk of sediment entry.

<p>Observation 4: One stormwater inlet on Conferta Avenue was not adequately protected and risk of sediment entry was identified.</p> <p>Recommendation: Provide and maintain adequate controls around stormwater inlets to reduce the risk of sediment entry.</p>	
DISPOSAL OF SEEPAGE AND STORMWATER				
D24	Any seepage or rainwater collected on-site during construction or groundwater must not be pumped to the street stormwater system unless separate prior approval is given in writing by the EPA in accordance with the <i>Protection of the Environment Operations Act 1997</i> .	<ul style="list-style-type: none"> • Dewatering Management Plan, Rev02 2/5/2023 • Site inspection 17/10/2024 • Interview with Auditees • NRAR Letter to EI Australia, dated 24/9/2021 • Email from NRAR, dated 8/10/2021 	<p>The discharge of water has been addressed in the Dewatering Management Plan, approved by NRAR.</p> <p>Email from NRAR, dated 8/10/2021 states Condition D24 has been met as outlined in their letter, dated 24/9/2021. <i>(It is noted that NRAR's letter, dated 24/9/2021 does not refer to Condition D24). This condition has been assessed as compliant based on NRAR's letter, dated 8/10/2021 confirming compliance with D24.</i></p> <p>EI Australia has been engaged by Deicorp to manage the discharge of seepage and rainwater from the site (dewatering). Refer to commentary for D25 and D26.</p>	Compliant

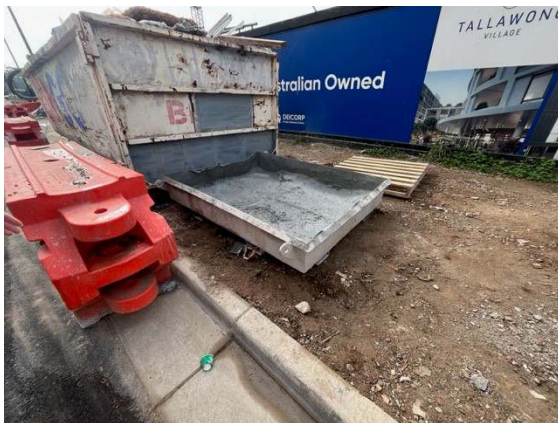
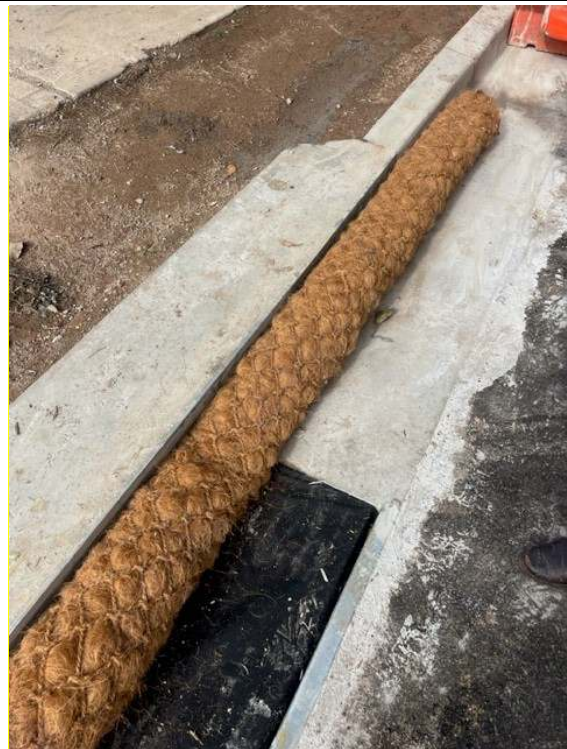
Photos 20 & 21: A concrete washout tray was in place on the nature strip. A concrete spill appeared to have been cleaned up in the vicinity of the stormwater inlet on Conferta Ave. An investigation was recommended to be undertaken by the auditor.

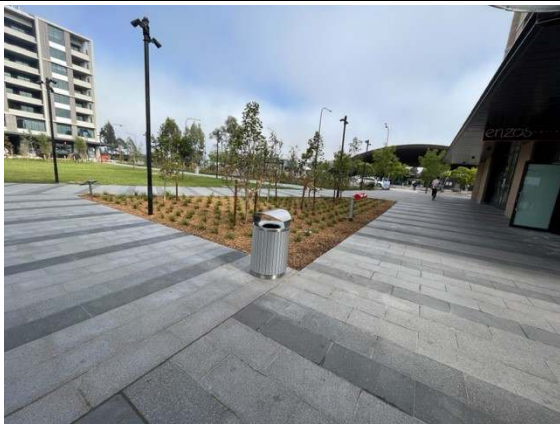
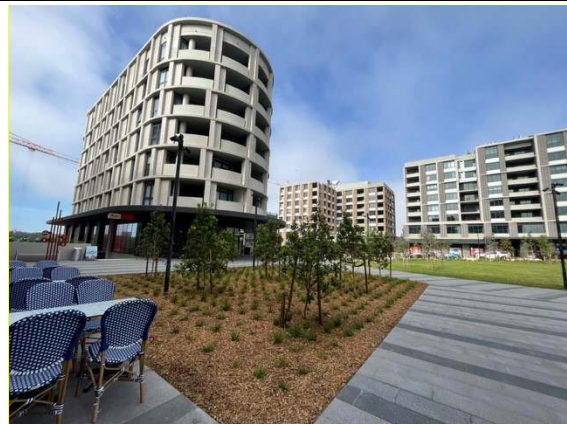
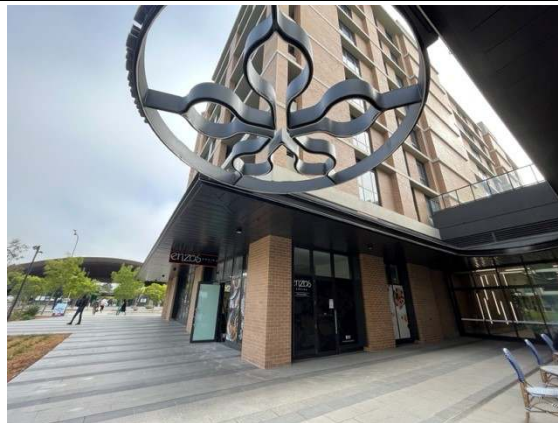
Photos 22-24: Site 1 was complete with retail open to the public and residents moved into apartment towers.
