OBSERVATIONS

ACTIONS

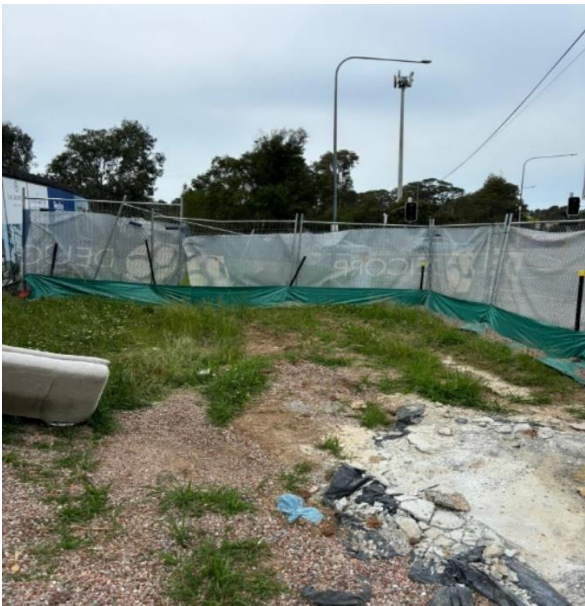
23 October 2024

A26	Observation # 1	Include a time frame for actions close-out for future action list	
D8	Observation # 2	Include a time frame for actions close-out for future action list	
D23	Observation # 3	<p>The sediment fence has been well maintained as shown on the below figures.</p>

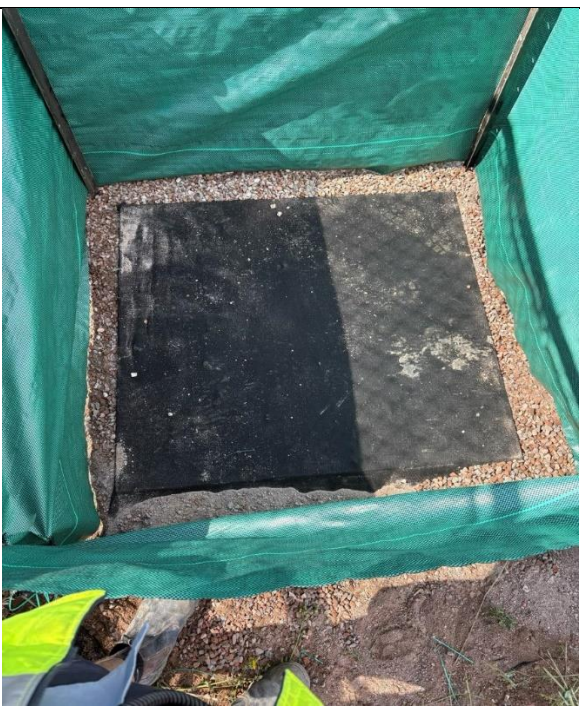
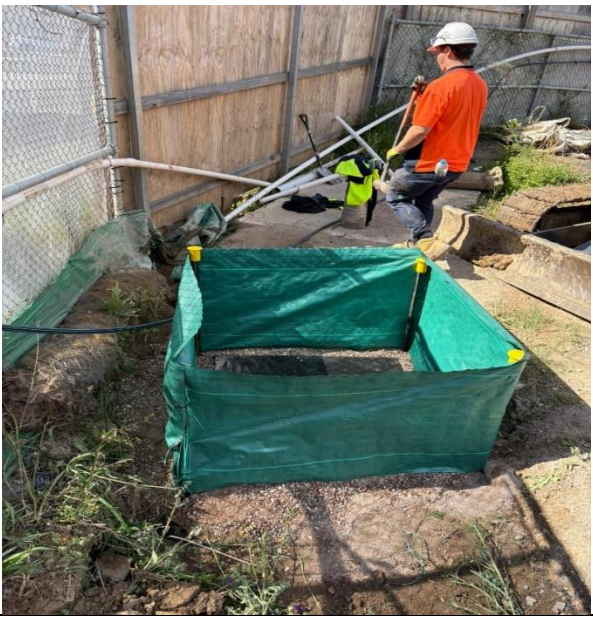
Observation # 4	The stormwater inlet has been maintained and the risk of sediment entry was eliminated.	22 October 2024
