OBSERVATIONS

ACTIONS

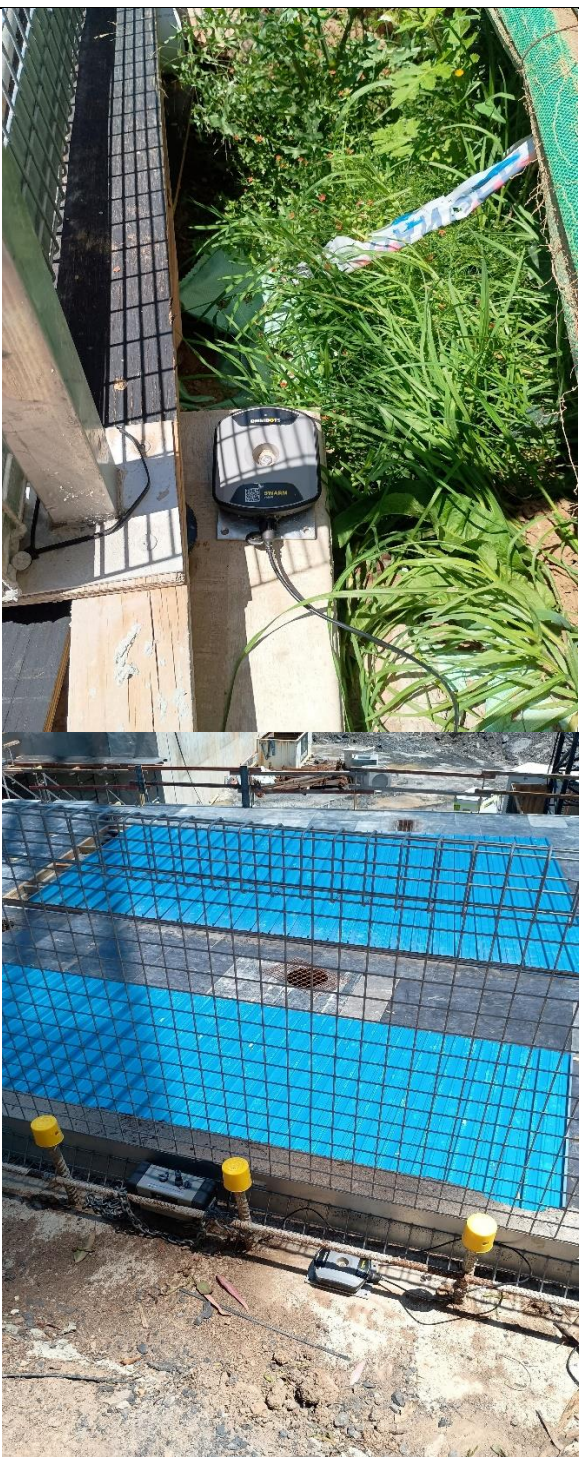
DA Condition	Observation / Non Conformance	Action	Time Frame
DA 20	Non-Conformance #1	Vibration monitoring was carried out on Site 2 to closely monitor and mitigate any noise-related activities that had the potential to exceed the prescribed noise level limits. Appropriate measures were implemented to minimize such occurrences.	10/11/2024
